Hazards of Unintended Movement of Dump Truck Body Beds

Safety and Health Information Bulletin

SHIB 09-18-2006

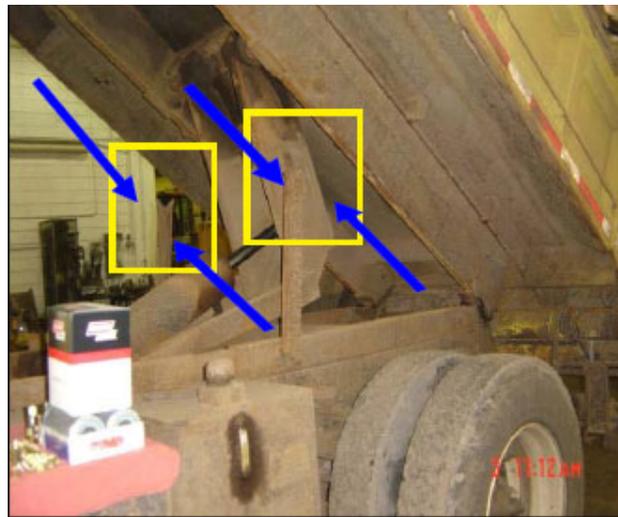
Figure 1. Body props are commonly misused when raised upright without having the weight of the bed supported or braced. Body props are subject to rust and damage, and need to be properly maintained.

One reason that the props provided by the truck body manufacturers are not used, or are not used appropriately, is that when raised to the typical body prop height, there may not be sufficient accessible space to perform the needed maintenance.

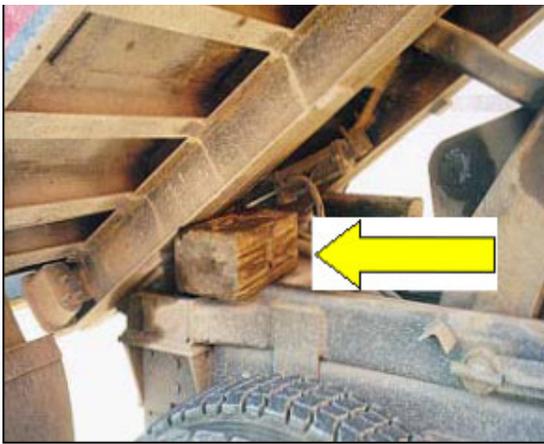
Figure 2. Shows a wooden block makeshift body prop.

The supports/cribbing methods shown in Figures 2 and 3 are examples of makeshift body props that do not safely support the dump body in an elevated position. Since these makeshift devices are not designed to safely support the elevated dump body they can inadvertently slip out of the truck frame while maintenance work is performed underneath the dump body.

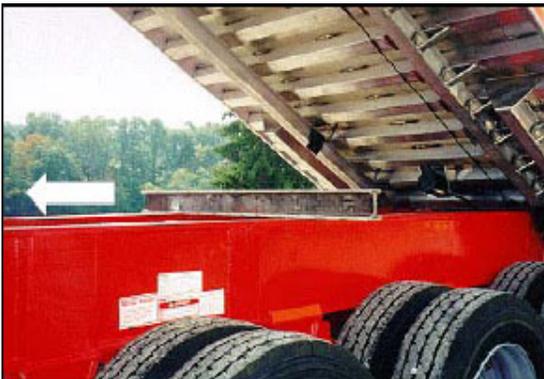
Figure 3. Shows a steel I-beam makeshift body prop: steel I-beam sits across truck frame. The I-beam is not attached to the truck frame or dump body. The I-beam could be displaced in the direction of the arrow by the inadvertent movement of the dump body or truck frame.

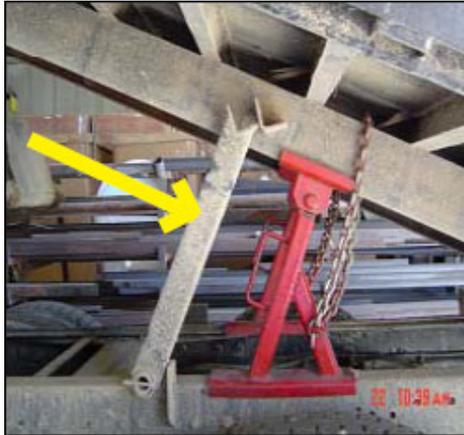
Figure 4. Positive supports are provided by dump bed manufacturers in the form of body props. Body props are non-adjustable and will support the dump body at one position only.

Strong, heavy, positive supports are provided by dump bed manufacturers in the form of body props. Body props are non-adjustable and will support the dump body at only one position that is close to the maximum elevated dump angle. Therefore, the need to inspect and/or work on the dump bed at an angle other than the one provided by the body prop will require additional or alternative protection.

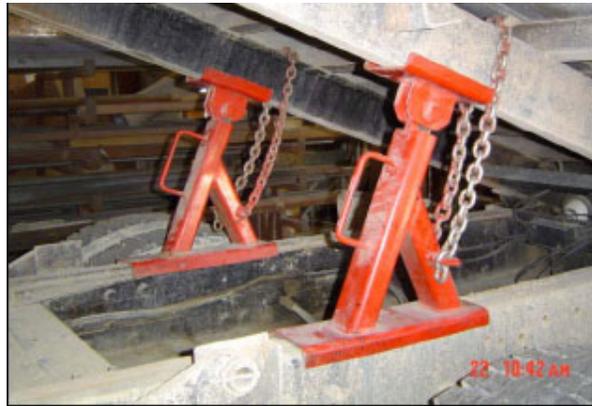
Figure 5. Engineered truck bed brace brackets.

As a result of the significant risk of injury or death to employees working between the frame and dump box of a dump truck, one employer developed braces to secure the dump box while employees serviced areas on the rear axles, or drive lines, and repaired the air cylinders for the tailgates that was not reachable using the manufacturer's prop. Three tests were conducted on one prototype brace at the Structures and Materials Testing Laboratory at the University of Wisconsin - Madison using a 1-million pound test machine calibrated to National Institute of Standards and Technology (NIST) traceable standards. Loads were applied to the brackets at the rate of 10,000 lbs./min. The braces successfully passed the test.

The following is an example of the prototype truck bed brace brackets (see Figures 5, 6 and 7) that were developed by the employer and can be used universally on any brand of dump box. The standard flange is 3.5 inches and the braces will fit up to a 4.5 inch channel. In addition, these braces have a handle that allows the employee to place the brace under the dump box without creating an additional hazard. The employee must rest the brace on the frame of the truck while standing next to the tires.

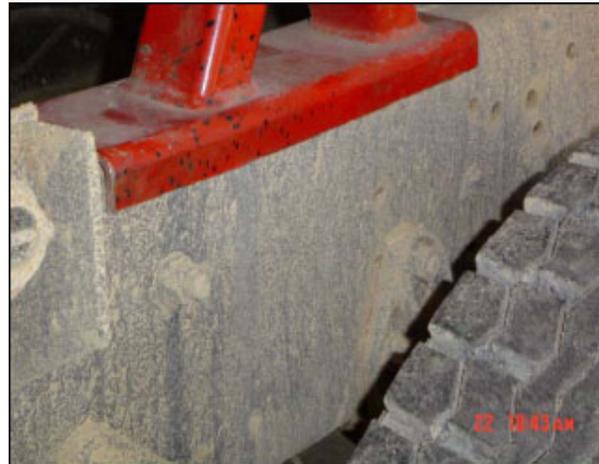
Figure 6. Truck bed brace bracket (bottom channel).

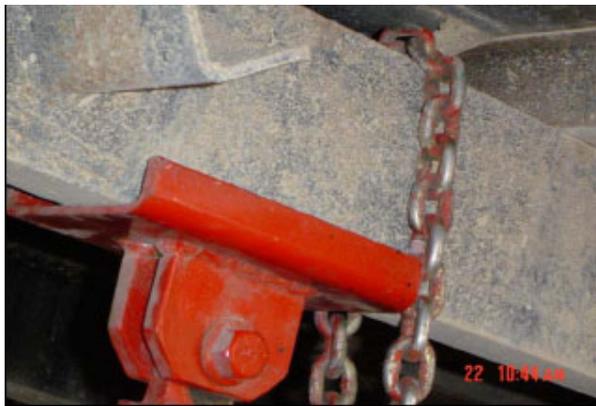
Figure 7. Truck bed brace bracket (top channel supporting dump body.)
